ALABAMA DEPARTMENT OF ENVIRONMENTAL MANAGEMENT
 WATER DIVISION – INDUSTRIAL AND MUNICIPAL SECTIONS
NONCOMPLIANCE NOTIFICATION FORM

PERMITTEE NAME: Cahaba River WWTP PERMIT NO: AL0023027

DMR REPORTING PERIOD: September 2014

JEFFERSON COUNTY, ALABAMA
CAHABA RIVER AND TRUSSVILLE WWTPs PHASE I TMDL IMPROVEMENTS
Jefferson County Project No. E.01026.W.C / CDM Smith Project No. 73998-98293
SUBMITTAL REVIEW COMMENTS

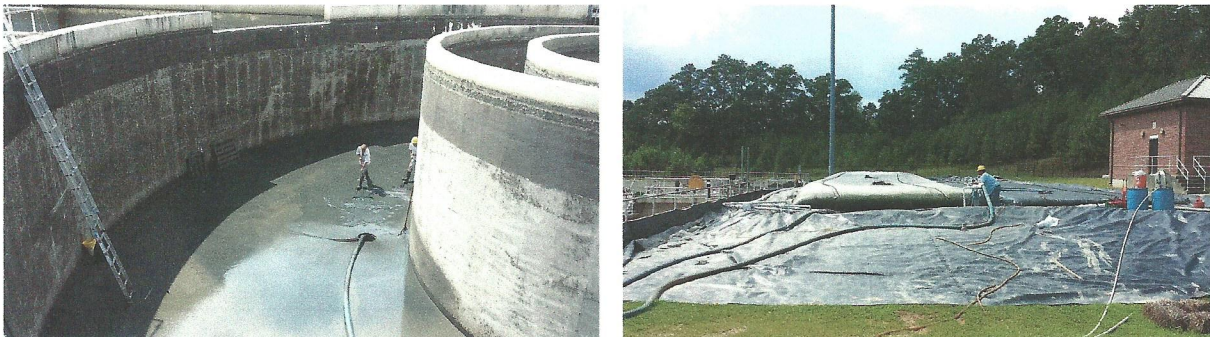
The below photos were taken on September 4, 2014 showing the current sludge removal and dewatering activities on the eastern carousel. The western BNR reactor is in service. In accordance with the plan, the average daily flow to the treatment plant was reduced to less than 6 MGD, the capacity of the western BNR reactor, by pumping more of the raw wastewater flow from the Al Seier pump station to the Valley Creek WWTP.

Beginning on August 19, 2014 and prior to the floor-level sludge removal, all five treatment zones in the eastern BNR system were drained to the WWTP's aerated peak flow holding basins. The liquid contents of the drained carousel were being slowly reintroduced into the active BNR reactor to minimize impact to the system. Increasing the hold time in the aerated holding basin was a conservative approach intended to minimize impacts to the active BNR; however, it led to septic conditions developing in the aerated holding basin which were observed on August 30, 2014. This liquid was heavy in MLSS and the aeration system within the peak flow basins proved incapable of supplying sufficient dissolved oxygen to keep the basin contents aerobic while daily high temperatures exceeded 90 degrees. The septic conditions contributed to the release of higher than normal ammonia and soluble CBOD in the holding basin return to the active BNR system. The sludge that remained in the carousel was being pumped to a geotube filter and the filtrate returned to the active BNR system. The filtrate also contains high levels of ammonia and CBOD.
